2017 SSA REMEDIAL MEASURES, SUB-BASIN MC08 PROJECT NO. 19-17-C1

SUMMARY

PROJECT REPORT

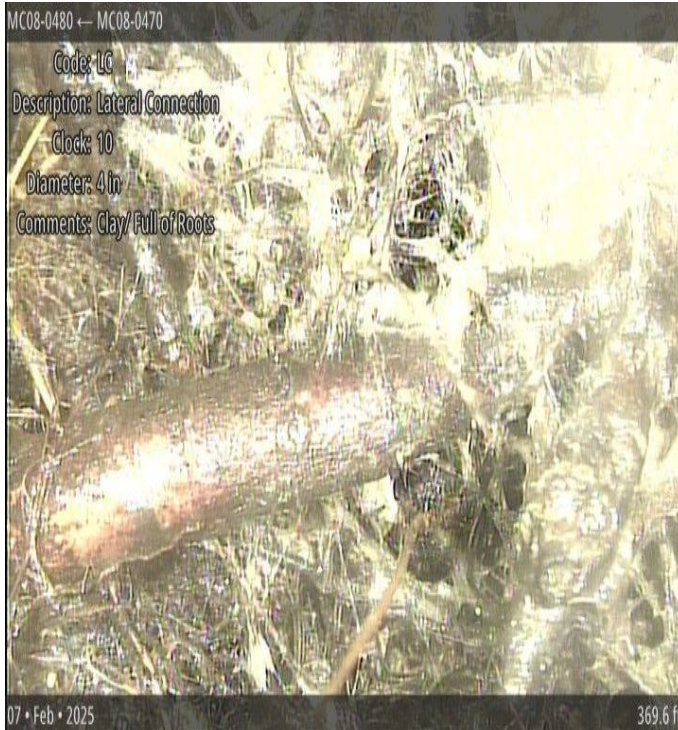
**PRE-CCTV VIDEO INSPECTION OF
SANITARY SEWER MAIN
(ROOT INTRUSION OBSERVED)**

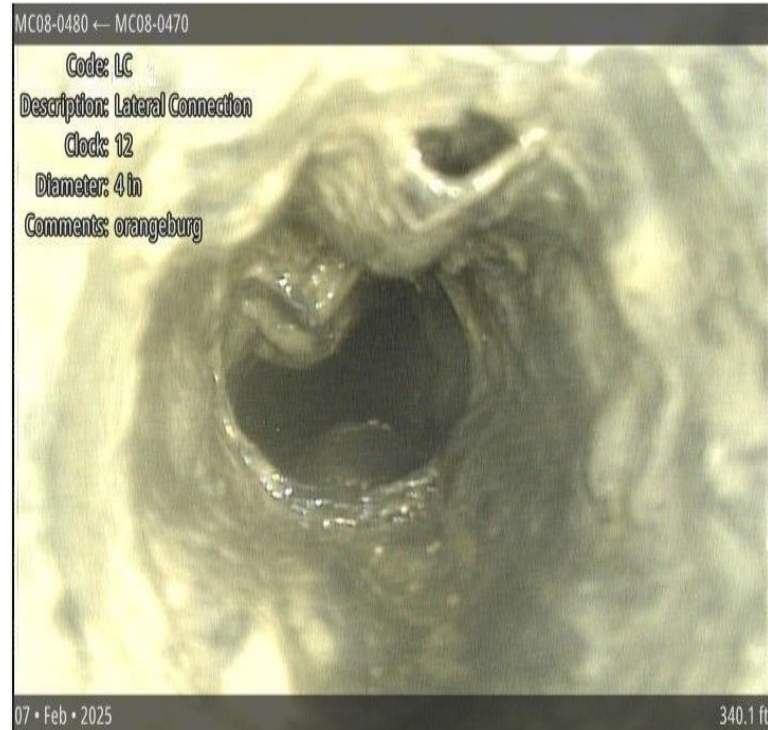
**PRE-CCTV VIDEO INSPECTION OF SANITARY
SEWER LATERAL CONNECTION**

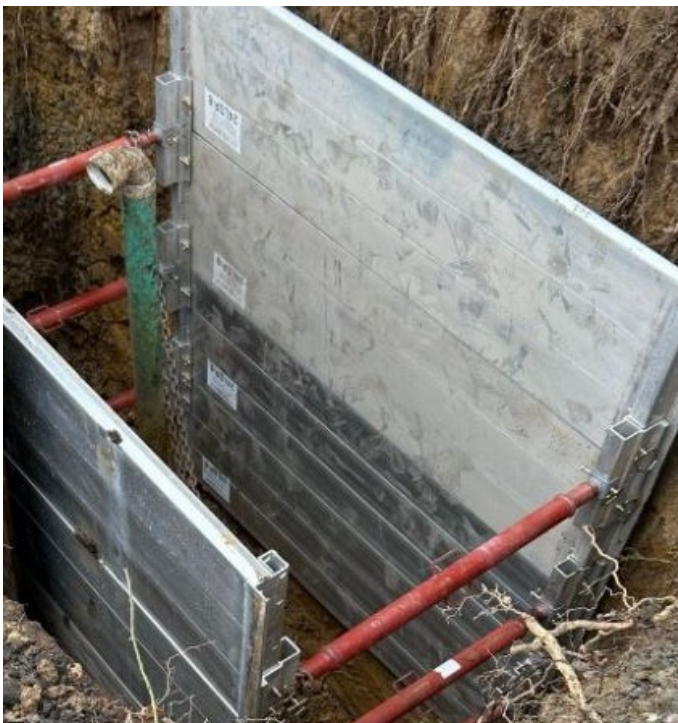
**MINOR POINT-BASED REPAIR PROCESS
FOR SANITARY SEWER MAIN LINES**

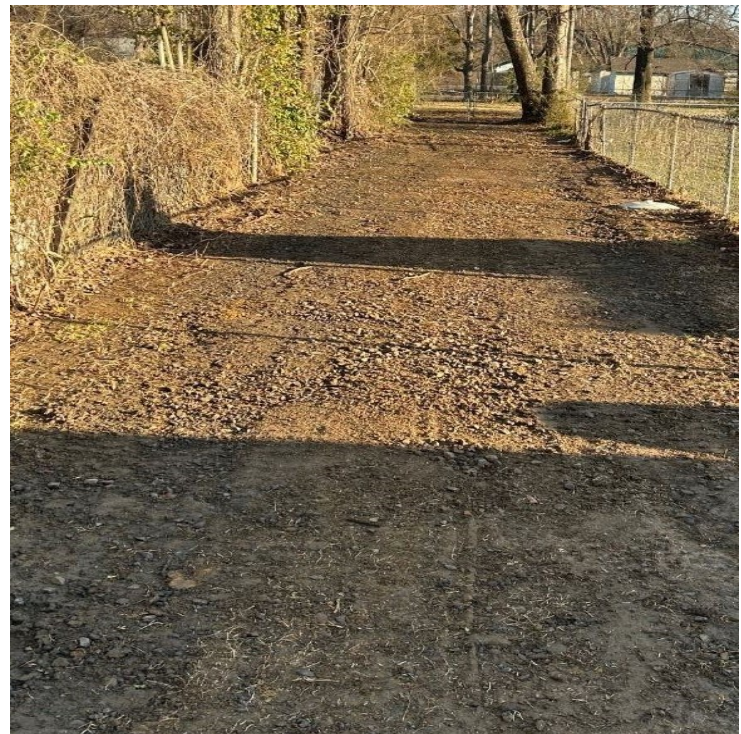
**POST-REPAIR SITE RESTORATION FOR
SANITARY SEWER MAIN LINES**

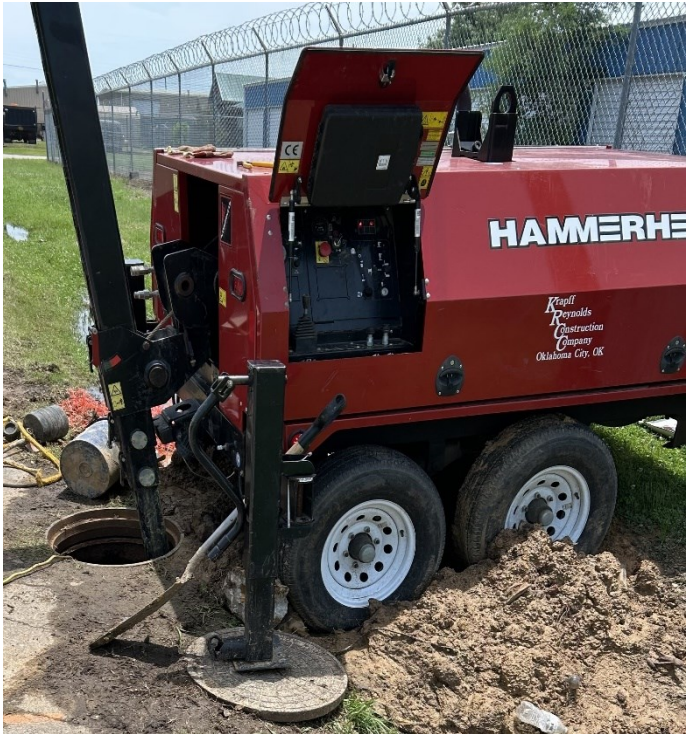
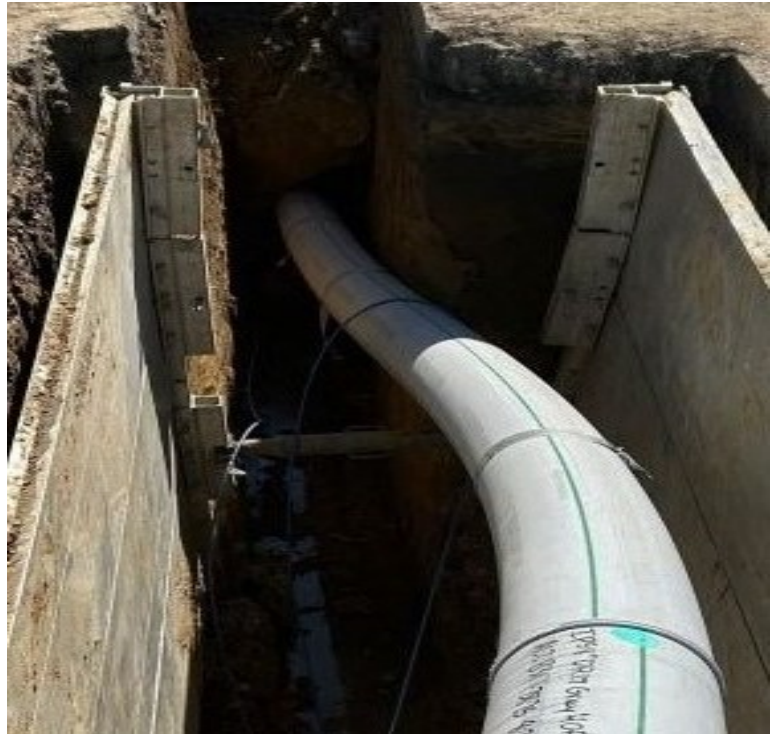
REPLACEMENT OF SANITARY SEWER MAIN LINE USING PIPE BURSTING METHOD

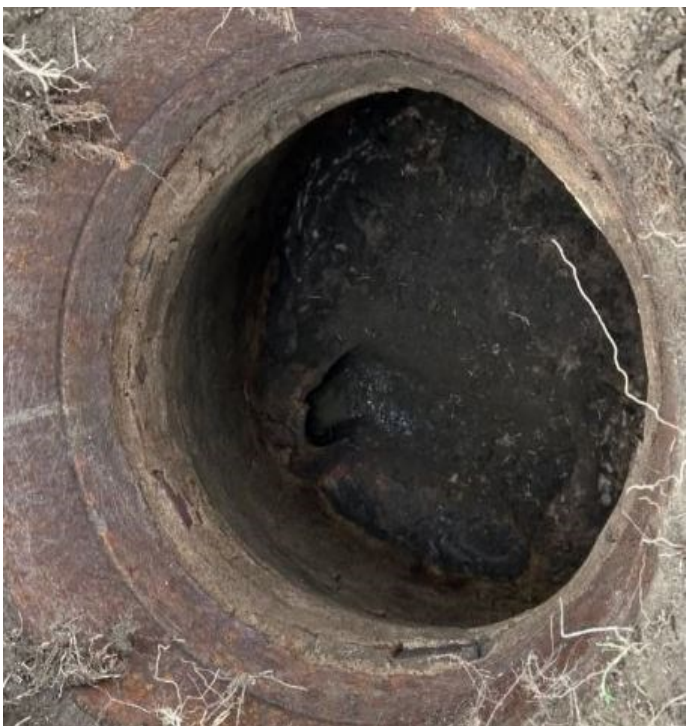
EXISTING MANHOLE CONDITION BEFORE REHAB OR REPLACEMENT WORK

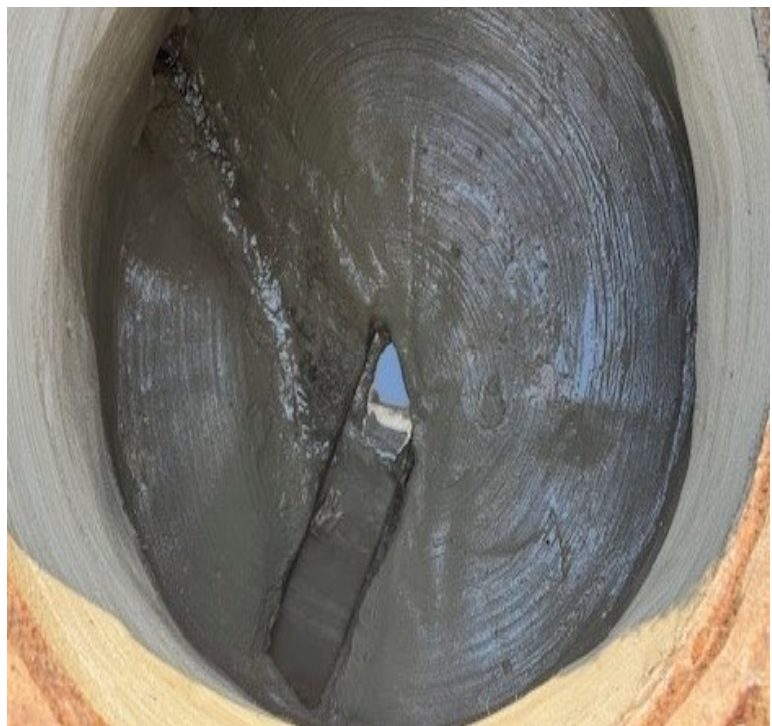
PROCEDURE OF REHABILITATING EXISTING MANHOLES

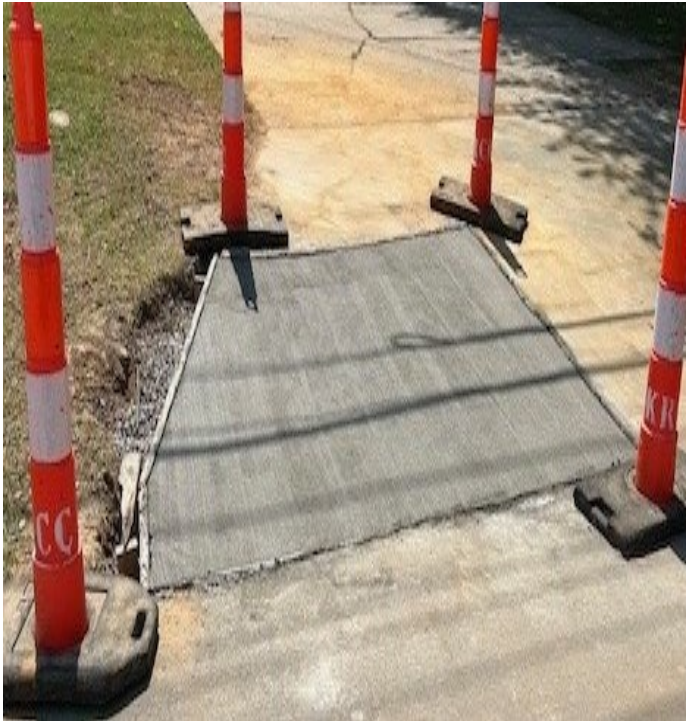
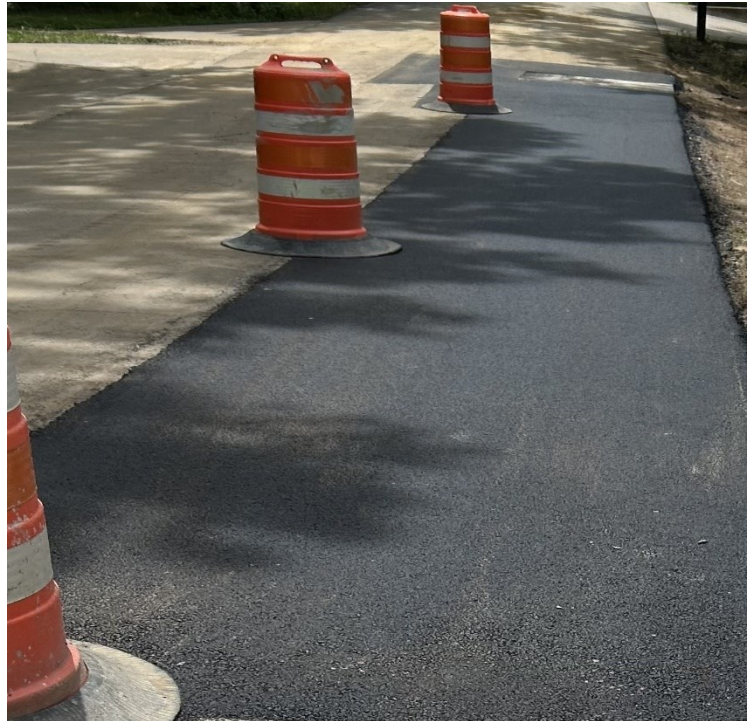
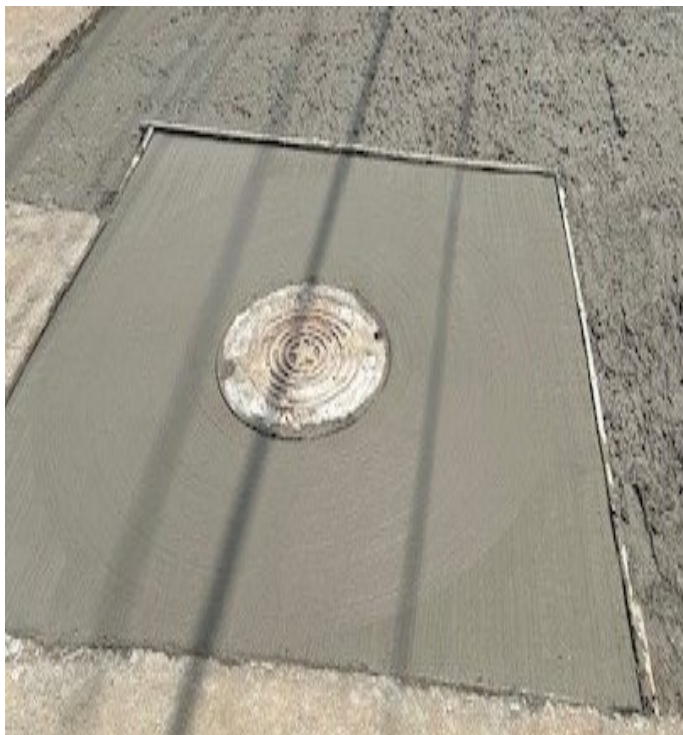
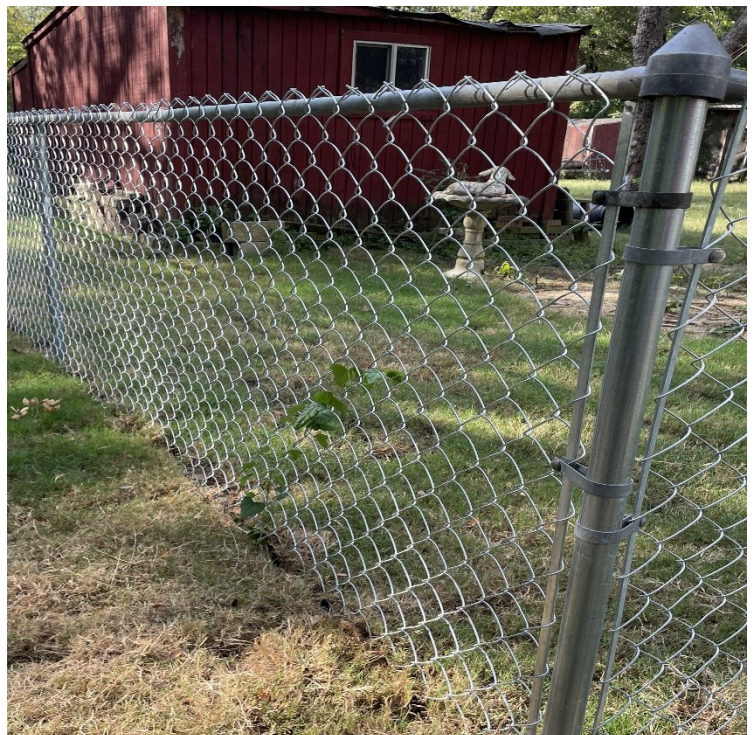
**SITE RESTORATION PROCESS AFTER REPLACEMENT/REHABILITATION OF
SANITARY SEWER SYSTEM**

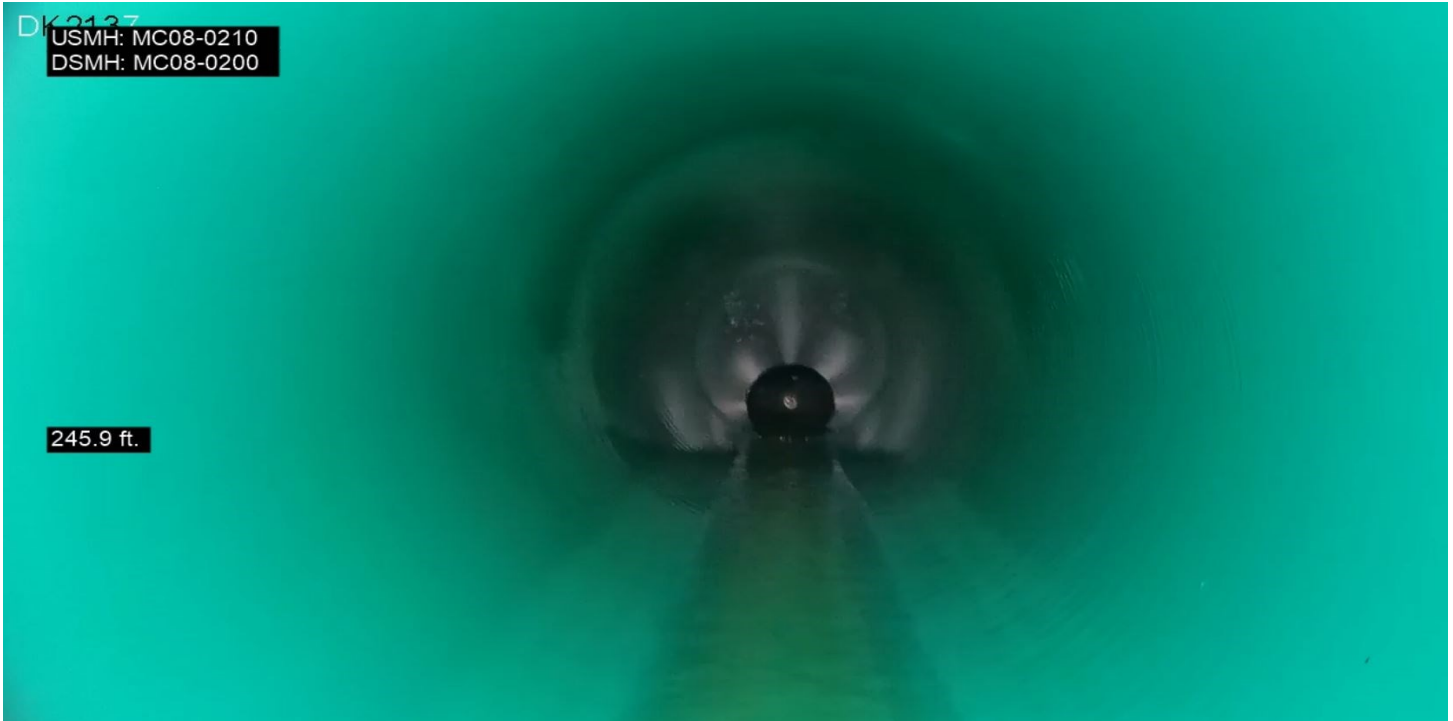
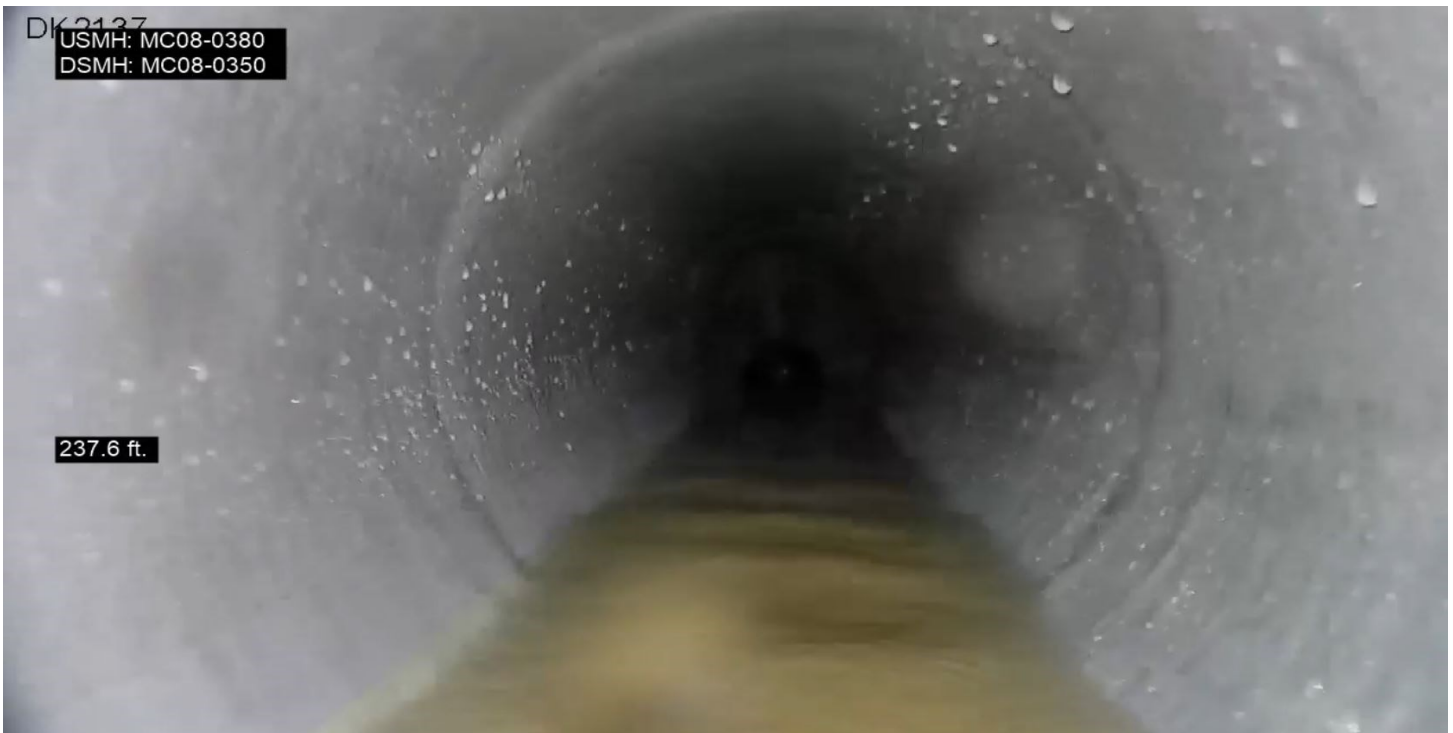
POST-CCTV INSPECTION PROCESS FOR SANITARY SEWER MAIN LINES
